# *Home Inspection Report*

*Inspector: Ben Tate*

*Inspection Date: 7/20/2026*

88th Ave W, Edmonds, WA 98026

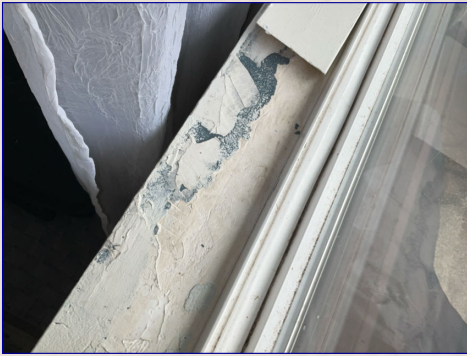
There are typical cracks on the walls/ceilings. Consult with a professional contractor to repair as needed.

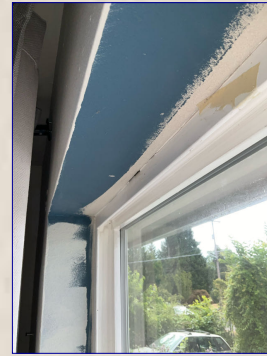
There are typical cracks on the walls/ceilings. Consult with a professional contractor to repair as needed.

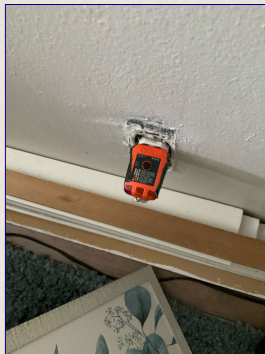
Electrical receptacle not operating

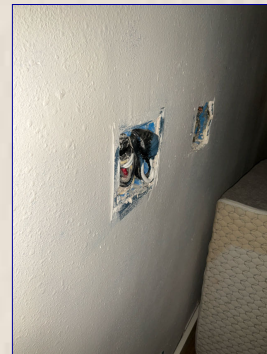
• Handyman wiring present, which is a potential safety concern. Recommend a licensed electrician evaluate and repair.

Handyman wiring present, which is a potential safety concern. Recommend a licensed electrician evaluate and repair.

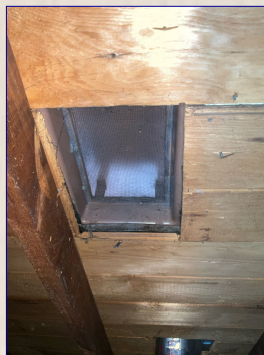
There appeared to be missing or insufficient ventilation in the attic. Calculating the attic ventilation is out of scope of a home inspection; however, there were visible deficiencies. Recommend a licensed contractor add additional ventilation.

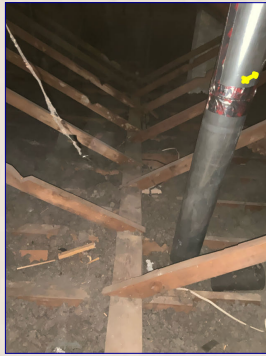
- There are cut rafters/trusses in the attic. Recommend a licensed structural engineer evaluate and repair or replace.

There are cut rafters/trusses in the attic. Recommend a licensed structural engineer evaluate and repair or replace.

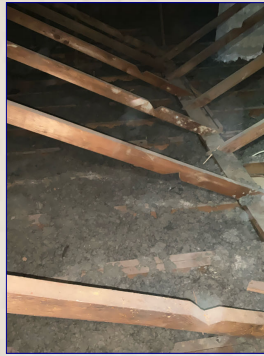
There are cut rafters/trusses in the attic. Recommend a licensed structural engineer evaluate and repair or replace.

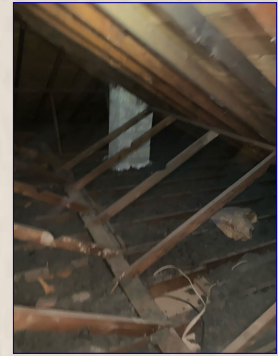
There are cut rafters/trusses in the attic. Recommend a licensed structural engineer evaluate and repair or replace.

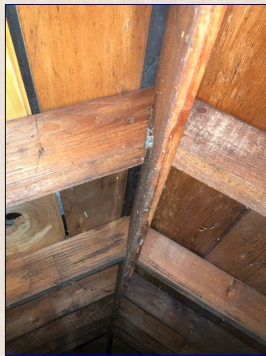
There is evidence of separating of rafters/trusses in the attic. Recommend a licensed structural engineer evaluate and repair or replace.

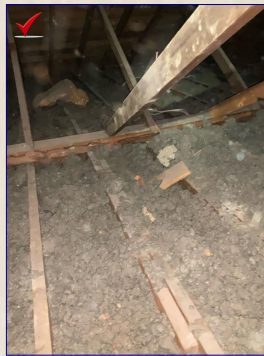
Signs of a missing support in the attic. Recommend a licensed structural engineer evaluate and repair or replace.

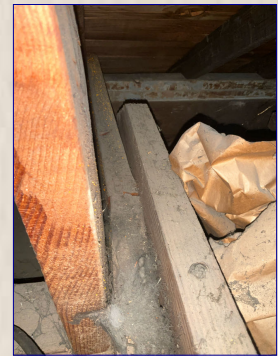
Signs of a missing support in the attic. Recommend a licensed structural engineer evaluate and repair or replace.

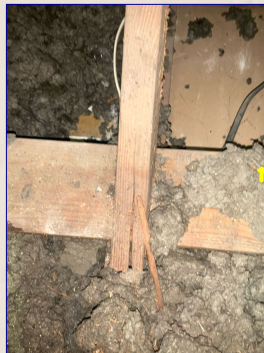
There are cracked rafters/trusses in the attic. Recommend a licensed structural engineer evaluate and repair or replace.

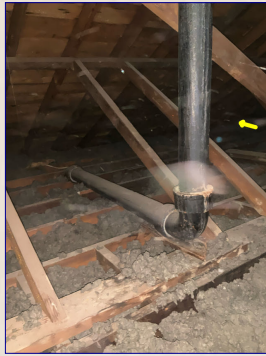
There is staining and evidence of moisture in the attic. Recommend a licensed roofer repair.

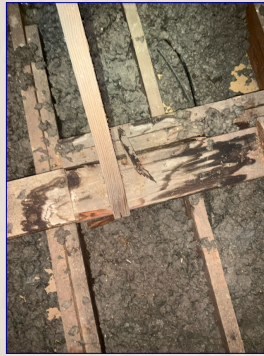
There is staining and evidence of moisture in the attic. Recommend a licensed roofer repair.

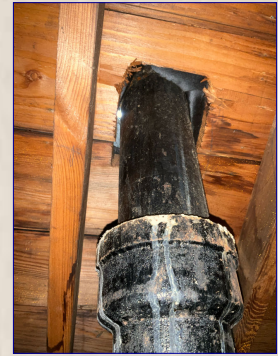
There is staining and evidence of moisture on the roof sheathing as viewed from the attic. Recommend a licensed roofer repair.

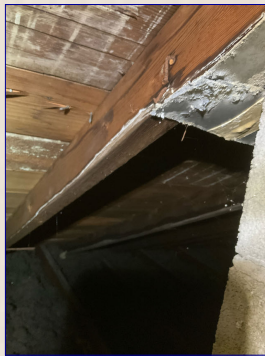
There is staining and evidence of prior moisture on the roof sheathing as viewed from the attic. No current moisture was detected during the inspection. Recommend monitoring and consulting a licensed roofer as needed.

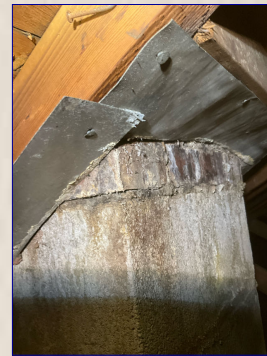
There is staining and evidence of prior moisture on the roof sheathing as viewed from the attic. No current moisture was detected during the inspection. Recommend monitoring and consulting a licensed roofer as needed.

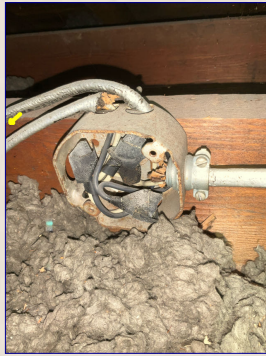
There is at least one open junction box missing its cover in the attic, which is a safety concern. Recommend a licensed electrician install a cover plate.

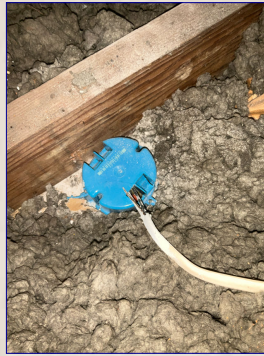
There are spliced wires that are not enclosed in junction boxes in the attic, which is a safety hazard. Recommend a licensed electrician repair.

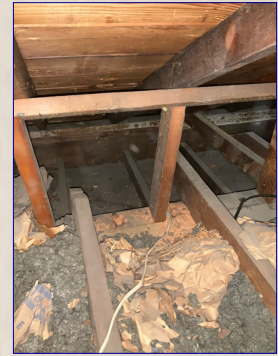
There is Romex wiring not properly installed/secured in the attic, which is a safety concern. A licensed electrician should be consulted to repair.

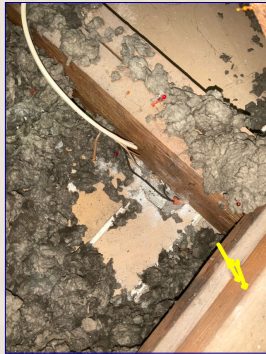
There are spliced wires that are not enclosed in junction boxes in the attic, which is a safety hazard. Recommend a licensed electrician repair.

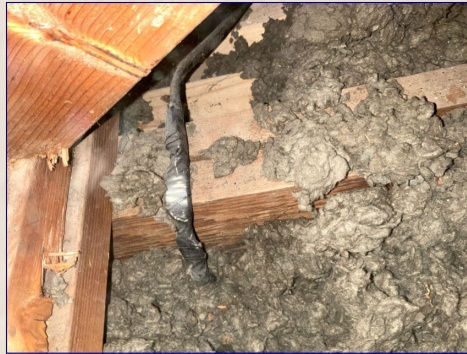
There are spliced wires that are not enclosed in junction boxes in the attic, which is a safety hazard. Recommend a licensed electrician repair.

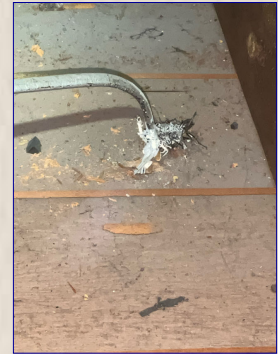
There is Romex wiring not properly installed/secured in the attic, which is a safety concern. A licensed electrician should be consulted to repair.

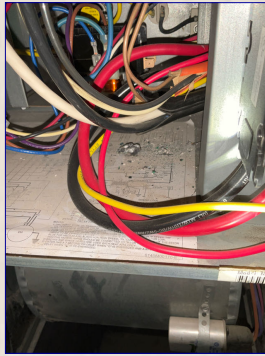
- System not operated due to: Blown transformer
- Recommend HVAC contractor evaluation/repair

- The heating system did not respond to normal controls during testing. Recommend further evaluation and repair by a licensed HVAC contractor prior to closing.

The furnace did not operate when tested. Recommend further evaluation and repair by a licensed HVAC contractor prior to closing.

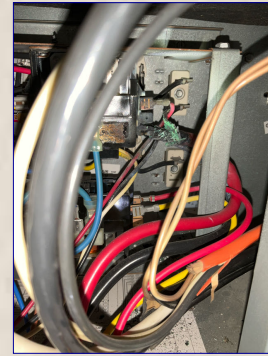
The furnace was in poor condition. Signs of a fire. Recommend a licensed HVAC contractor evaluation and certification before closing. Repairs or replacements should be made by a qualified licensed contractor.
